NAVAL WEAPONS CENTER CHINA LAKE CA
SOIL STABILIZATION PROJECT. (U)

(13) 346
(11) Mar 77
9) Final rept.
(18) GIDEP
(19) E144-2433
(16) SOIL STABILIZATION PROJECT FINAL REPORT

(14) NWC-TM-3818

March 1979

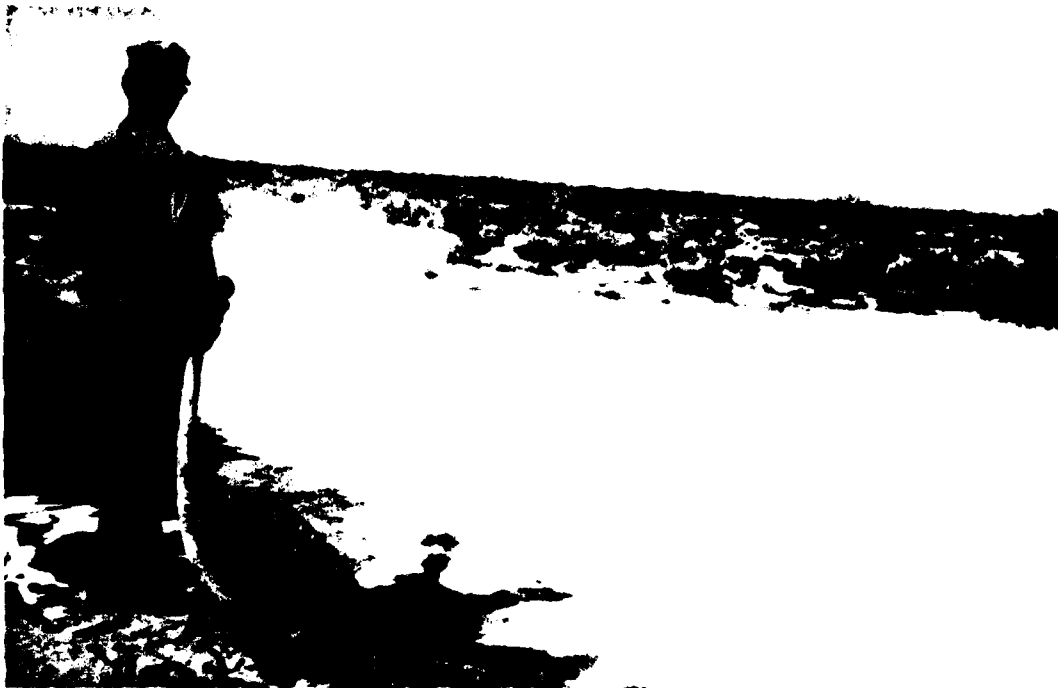
FIGURE 1. Fire Hose Application Method.

In late August 1977, a test was conducted to compare methods of application and determine the adequacy of the emulsion to stabilize the soil. Using a 10% aqueous latex emulsion, two applications methods were tried--fire hose (Figure 1) and truck spray-bar (Figure 2). Of the two, the fire hose method proved more satisfactory. As can be seen from Figure 3, the spray-bar side (right) of the helicopter pad was considerably roughened as a result of the heavy truck recrossing the area. Also, the light spot near the middle (upper) of the pad is where a surface strip peeled off due to the inadequacy of the spray-bar application method.

The fire hose application method resulted in an average emulsion penetration depth of approximately 1-1/8 inches; where puddling occurred in low spots penetration was as much as 3 inches. On the spray-bar application side, the average depth of penetration was 1-1/4 inches, except where puddling occurred and resulted in penetration of up to 2 inches.

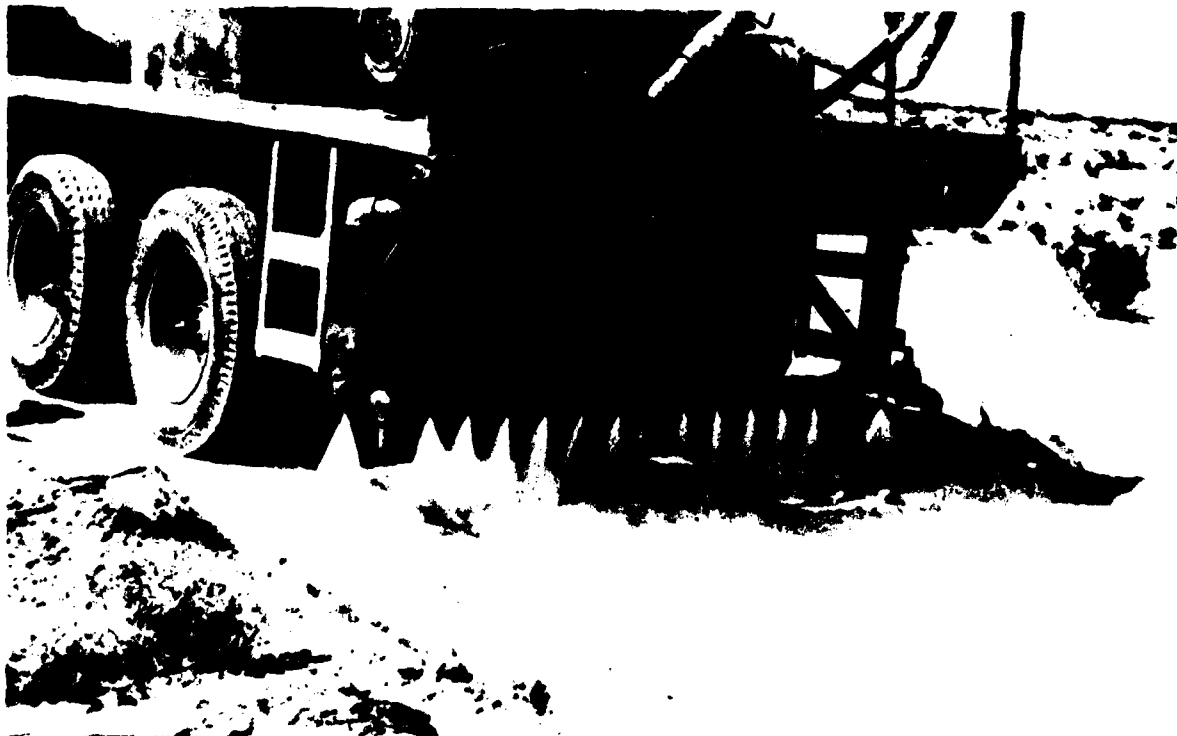
FIGURE 2. Truck Spray-bar Application Method.

The truck spray-bar application method tried earlier (NAF test) was definitely unsatisfactory. The fire hose technique was adequate but slow and cumbersome. It was therefore decided to try a sprinkler system.

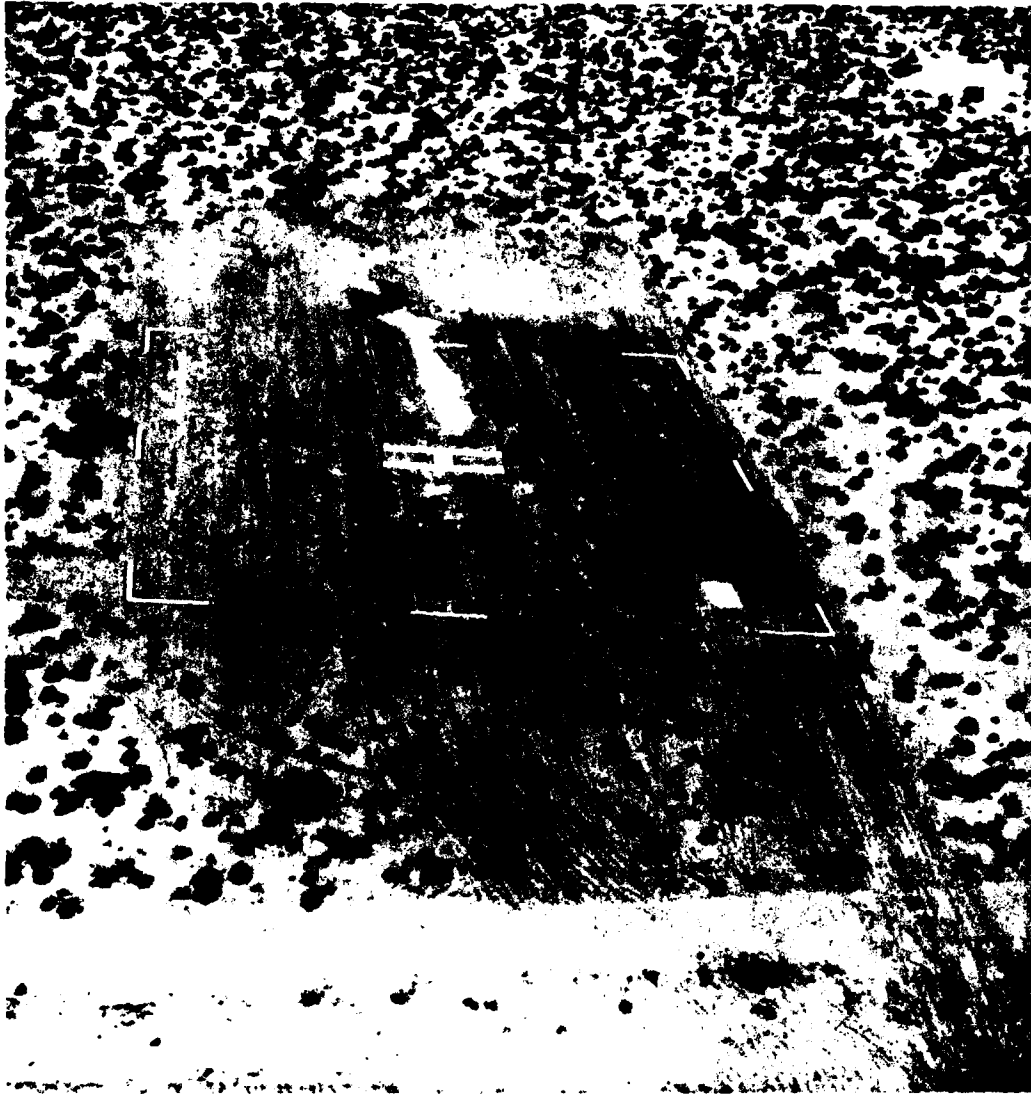
FIGURE 3. Aerial View of NAF Site After Application.

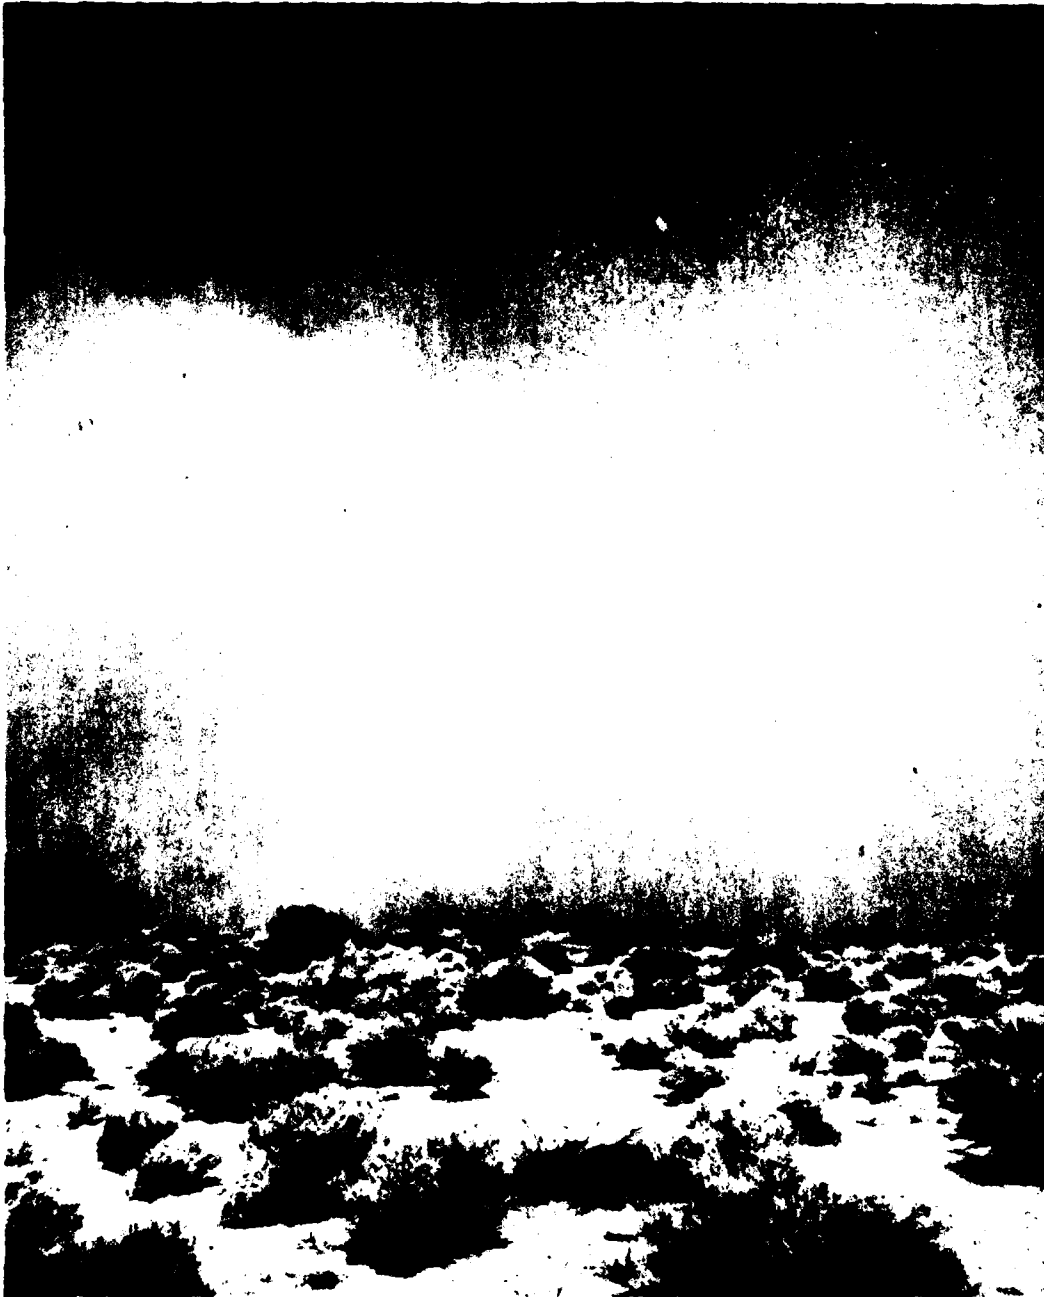
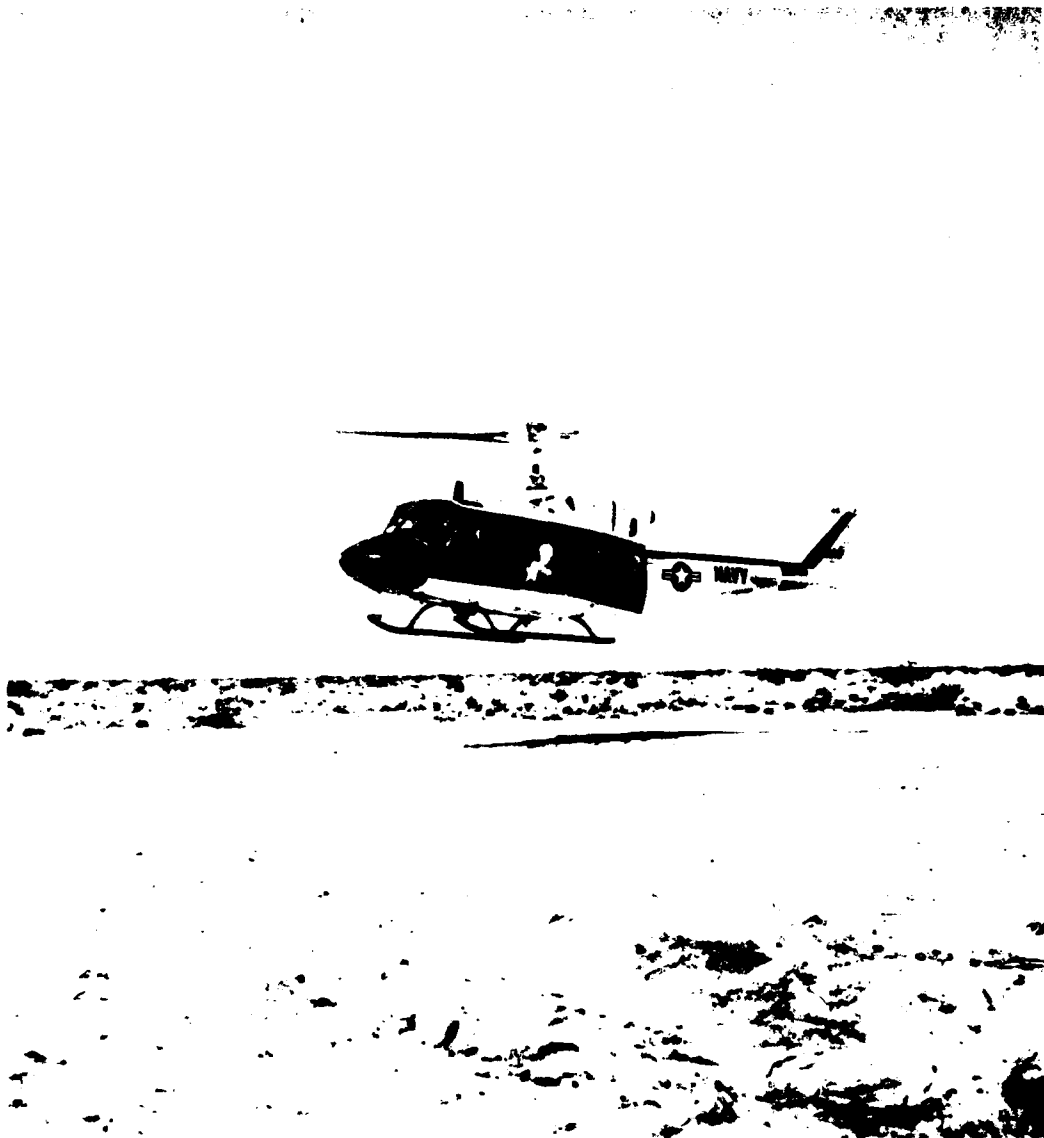
FIGURE 4. Helicopter Landing at NAF Site Before Application of Emulsion.

FIGURE 5. Helicopter Landing at NAF Site After Application of Emulsion.

After a 40 to 48 hour drying (cure) period, the ground was stabilized into an adequate helicopter landing pad. Figures 4 and 5 compare helicopter landing conditions before and after application of the emulsion. A helicopter landing operation did cause some damage to the surface soil (Figure 6), but this is easily and quickly repaired. The test pad has since withstood more than a year's weather with little damage.

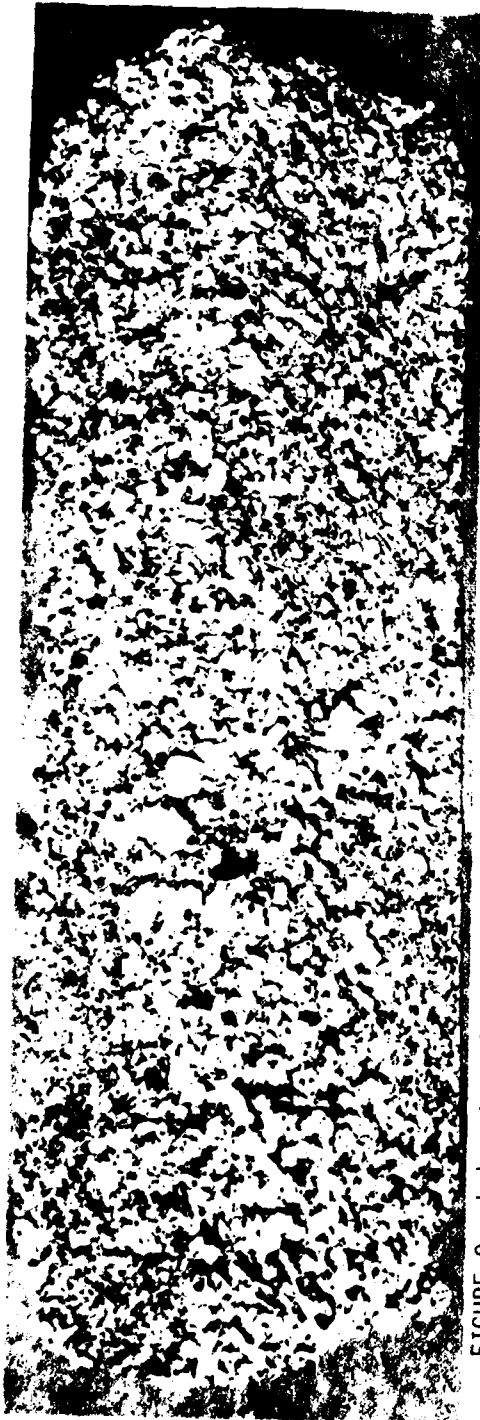
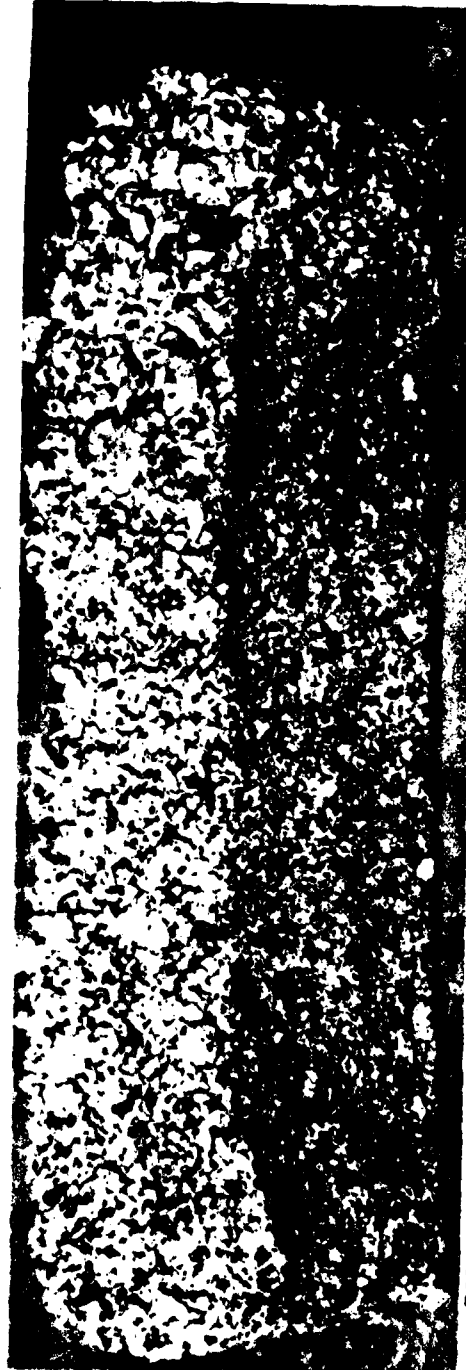
FIGURE 9. Laboratory Sample, Soil Type 1 (10% A-400 emulsion, time to absorption 1 minute, depth of penetration greater than 3 inches).

FIGURE 10. Laboratory Sample, Soil Type 1 (50% A-400 emulsion, time to absorption less than 2 minutes, depth of penetration greater than 3 inches).

Emulsion Concentration. In terms of penetration, emulsion concentration level had little impact on the type 1 soil samples. In most cases penetration was to the full depth of the sample. However, in every case, loose particles remained on the surface after sample cure. Figures 9 and 10 show type 1 soil samples after application and curing of a 10 and 50%, respectively, concentration emulsion. In each case the time to absorption was less than two minutes and penetration was to full depth; but, loose particles remained on the surface.

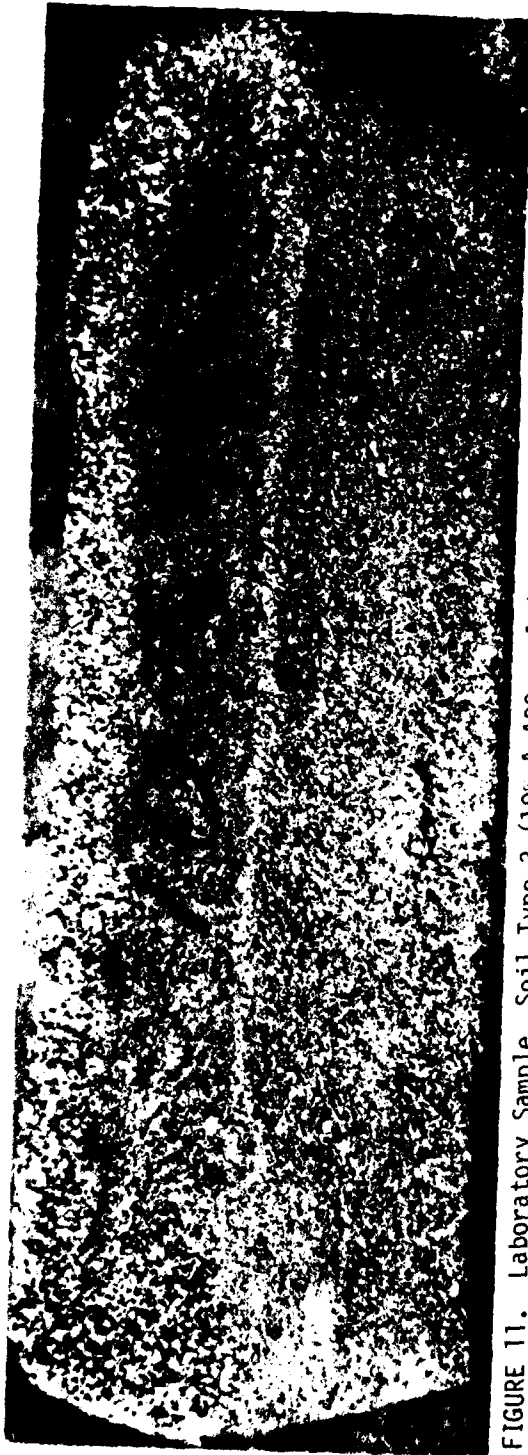
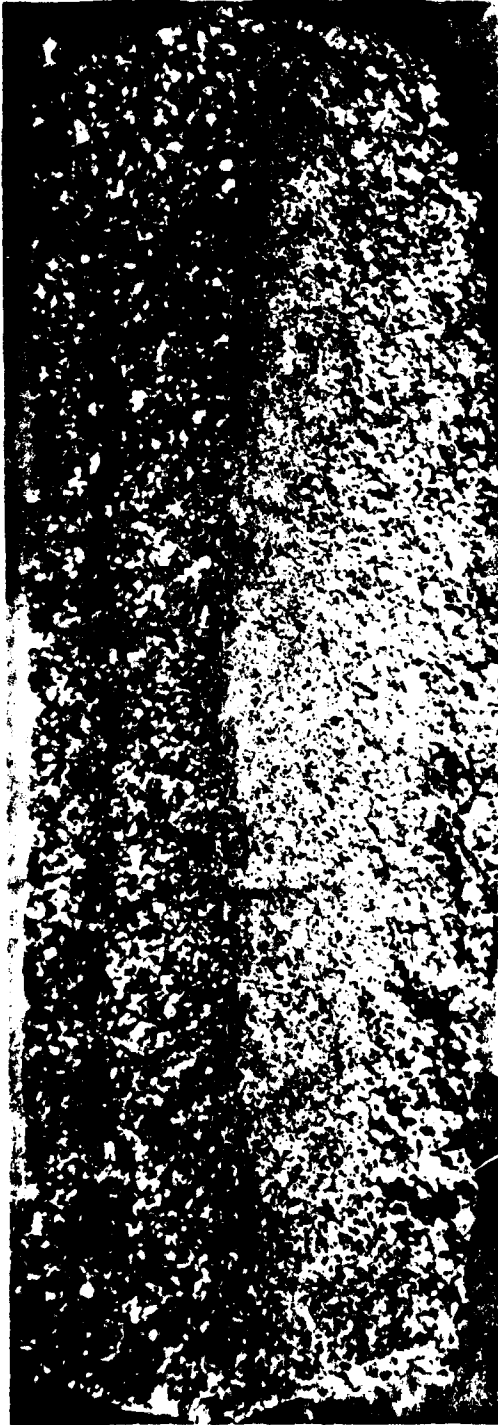
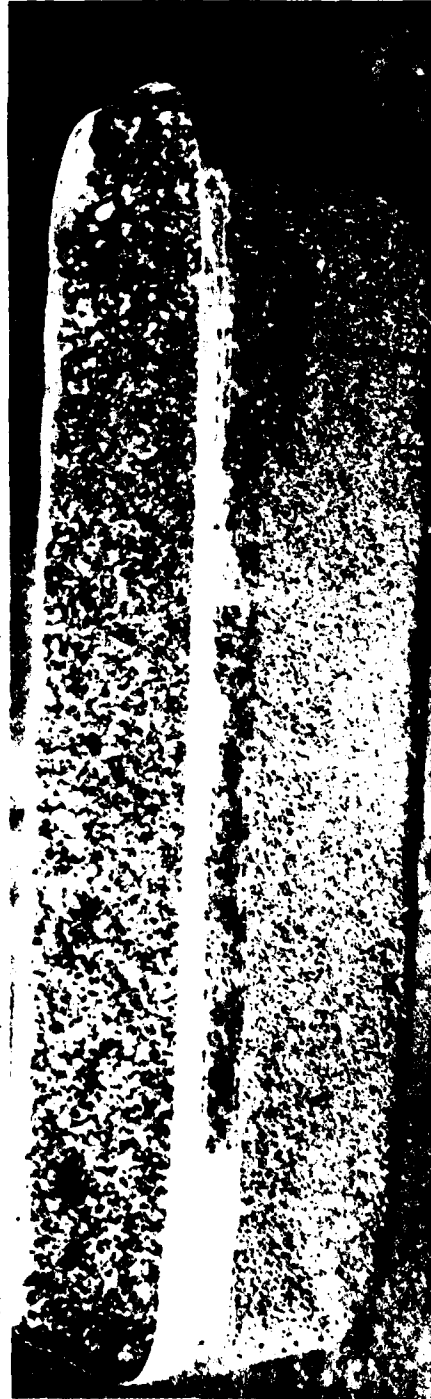
FIGURE 11. Laboratory Sample, Soil Type 3 (10% A-400 emulsion, time to absorption less than 1 minute, depth of penetration greater than 3 inches).

FIGURE 12. Laboratory Sample, Soil Type 3 (20% A-400 emulsion, time to absorption less than 1 minute, depth of penetration greater than 3 inches).

FIGURE 13. Laboratory Sample, Soil Type 3 (30% A-400 emulsion, time to absorption approx. 5 minutes, depth of penetration 3 inches).

FIGURE 14. Laboratory Sample, Soil Type 3 (5% followed by 10% A-400 emulsion, time to absorption 1 minute, depth of penetration 3 inches).

The type 3 soil samples treated with either 10, 20 or 30% concentration mixtures (Figures 11, 12 and 13, respectively) all experienced full penetration. In no case did time to absorption exceed five minutes. Samples treated with 40 or 50% concentration emulsion (both with and without a surfactant added) experienced significantly longer times to absorption and considerably reduced depths of penetration. One sample (Figure 14), previously treated with a 5% concentration mixture and cured, received a second coating using a 10% concentration mixture. This provided an even more stable surface.

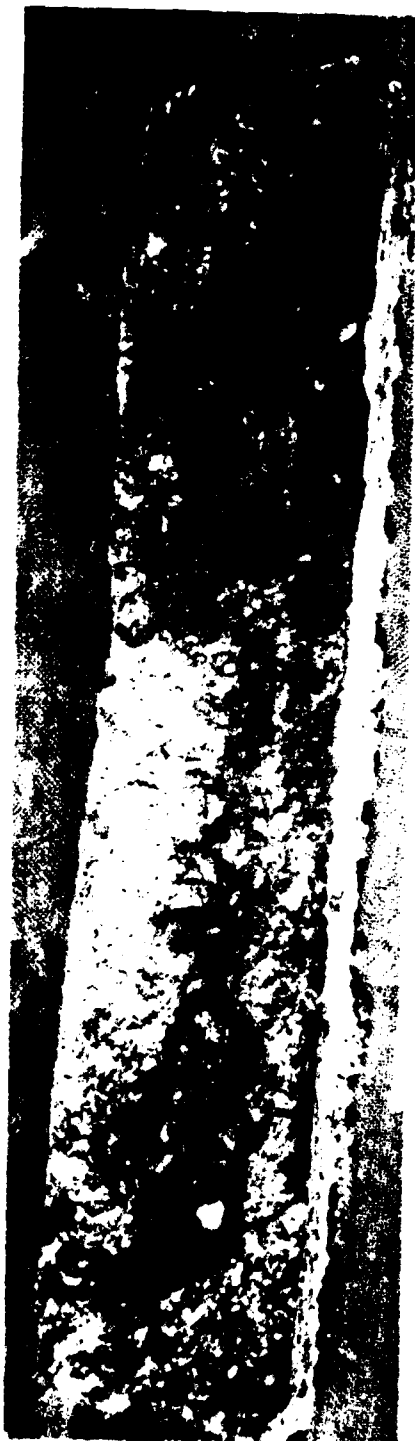
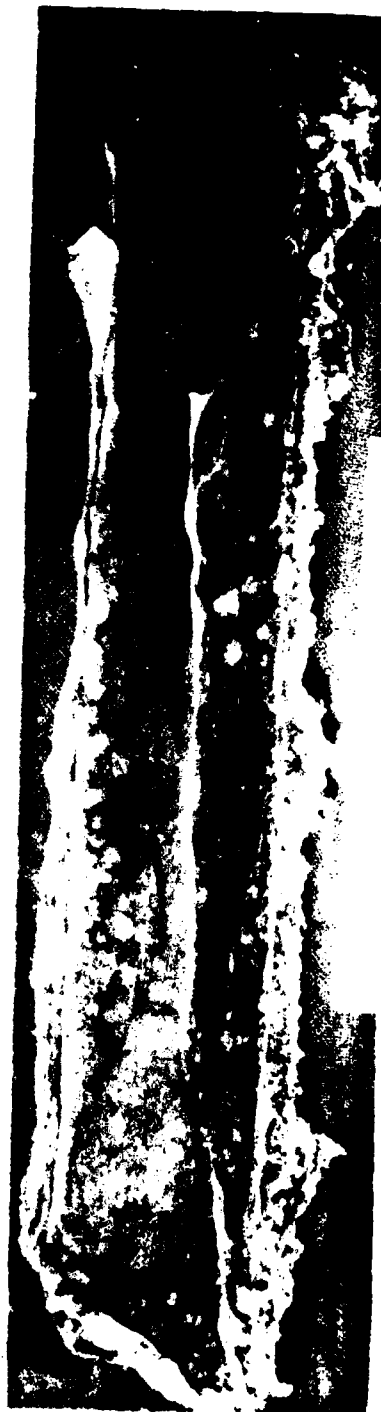
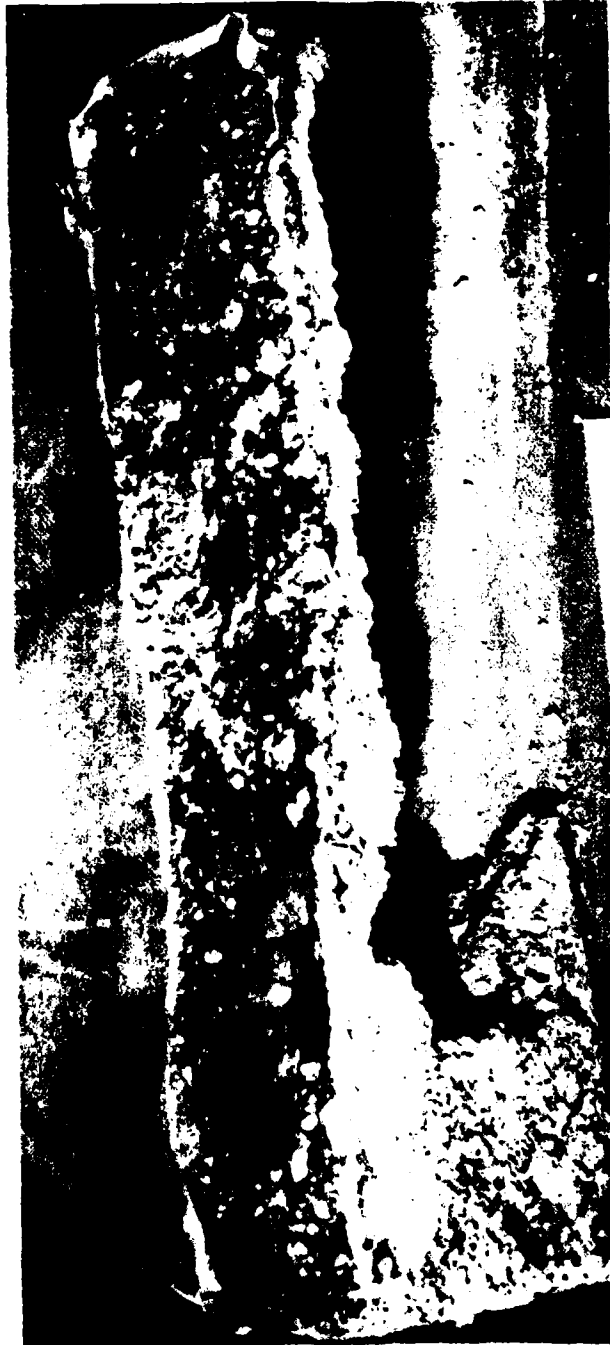
FIGURE 15. Laboratory Sample, Soil Type 4 (20% A-400 emulsion, time to absorption approx. 8 hours, depth of penetration $1/4$ inch).

FIGURE 16. Laboratory Sample, Soil Type 4 (50% A-400 emulsion, time to absorption approx. 64 hours, depth of penetration $1/16$ inch).

FIGURE 17. Laboratory Sample, Soil Type 4 (30% A-400 emulsion plus 20 ml soap, time to absorption approx. 1.5 hours, depth of penetration 1/2 inch).

As had been predicted by sieve analysis, the type 4 soils treated with emulsion-only mixtures did not show good penetration. No emulsion-only mixture, at any concentration, could significantly penetrate the silt and clay. The maximum penetration experienced was 1/2-inch. The times to absorption ranged from 8 (20% concentration, Figure 15) to 64 hours (50% concentration, Figure 16). The addition of soap (surfactant) to reduce surface tension (Figure 17) did improve penetration and time to absorption.

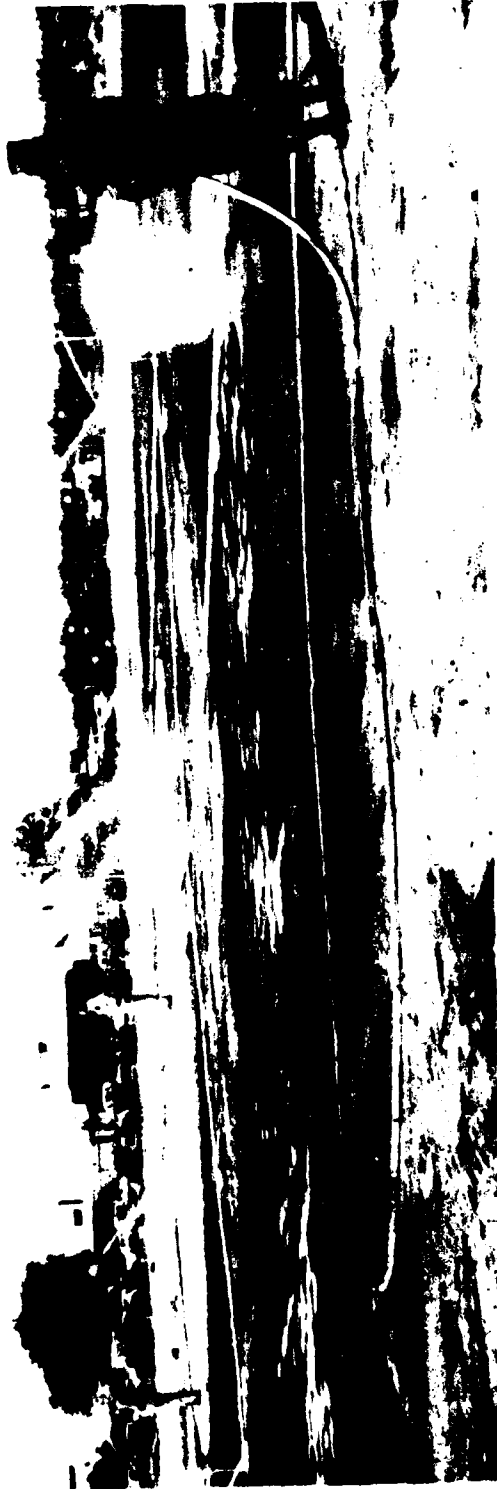
FIGURE 20. "Rainbird" Sprinkler Application Method.

A "rainbird" type sprinkler system, designed for quick assembly and disassembly, was subsequently designed and used in the demonstration tests.

On 19 October 1978, areas surrounding the hospital helicopter pad were treated with either a 5 or 10% concentration emulsion. Figure 19 is a diagram of the area treated and indicates the emulsion concentration (and whether or not a surfactant was added) for given areas. The circled area surrounding the concrete pad was treated with 4800 gallons of a 10% aqueous latex emulsion with 1% Renex-31 surfactant added. The quadrants further out from the circle were treated with either a 5 or 10% concentration emulsion (without surfactant). It was not originally planned to treat these outlying quadrants; however, recent removal of brush to minimize fire hazards necessitated that the surface be stabilized. The application methods employed (Figure 20) were truck-fed "rainbird" sprinklers and water hose.
